PUMPS & SYSTEMS[®]

Building a Better Boiler Feed Pump

Say goodbye to concerns about pump seizure: By properly applying composite materials to a troublesome boiler feed water pump, this large process facility in Alberta can now run one pump during full-rate operation with very low vibration and higher efficiency.

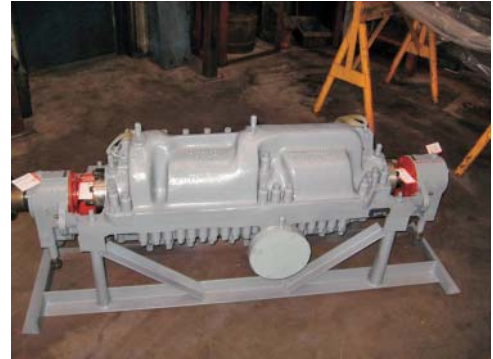
Figure 1. The 9-stage boiler feed water pump.

The pump involved is a common design for a process plant boiler feed water pump: 9-stage, horizontally-split, between-bearings design (see Figure 1).

This design includes a double-suction first-stage impeller with wear rings, an eye-side wear ring and inter-stage bushing at each of the other eight stages, two throat bushings, and a pressure reducing bushing between the 5th and 9th stages. The impellers are 9.125-in (232-mm) diameter, with 5-in (127-mm) diameter wear rings.

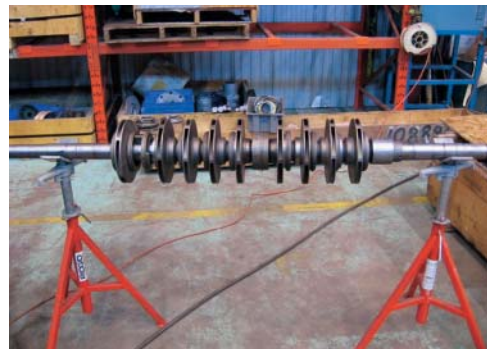
Figure 2. Rotor configuration.

This pump design creates unique challenges which are particularly suited to the application of composite wear components. The rotor configuration – a long, thin shaft (see Figure 2) suspended between bearings – relies heavily upon the wear rings for rotor stability.

While the pump is idle, there is substantial rotor sag (about 0.008-in/0.2-mm) at the center bushing. The rotor sag goes away only when the pump is running and hydrodynamic forces at the wear rings are established. During alignment of the pump to the driver, slow-roll (if coupled to a steam turbine driver), or at start-up, there will be contact at the center stage bushing and other wear components.

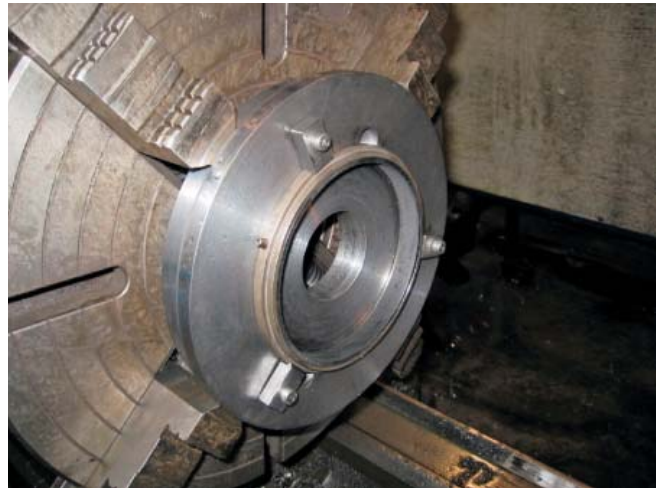
Figure 3. Composite insert in metal case ring holder.

Instead of fabricating new components with complex geometry for the stationary composite components, the existing components were used as holders for composite “inserts.” The existing metal bores were increased, and thin-radial-wall composite inserts were manufactured and pressed into the metal holders.

Additional design detail was needed for the split inter-stage bushings, as shown in Figure 3. Using the existing components as “holders” for the composite reduced the required machining time – eliminating the need for milling slots and other details on the outside diameter of the components.

To prevent axial movement of the composite, the metal holders incorporated a small shoulder on the low pressure side. There were no pins or screws used for anti-rotation purposes; the composite relying upon a heavy interference fit for anti-rotation. With a very low coefficient of friction and other properties that reduce risk of seizure, this method of installation has proven effective with this composite during the past ten years of field experience.

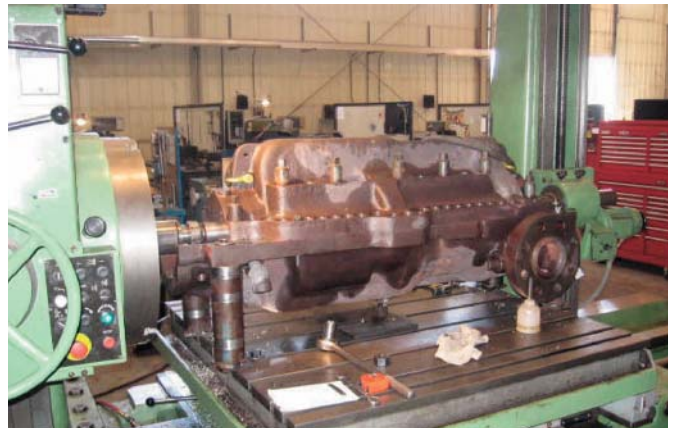
Figure 4. Line boring the pump case.

Before the rotor is installed, the pump should be fully inspected. The split-line should be checked to ensure it is true, the line bore and seal chamber bore should be checked for concentricity (see Figure 4), and the rotating element should have limited run-out (typically 0.002-in max).
