# The Top Ten Pump Problems You Can Solve with One Small Change

By Robert Aronen, Boulden International

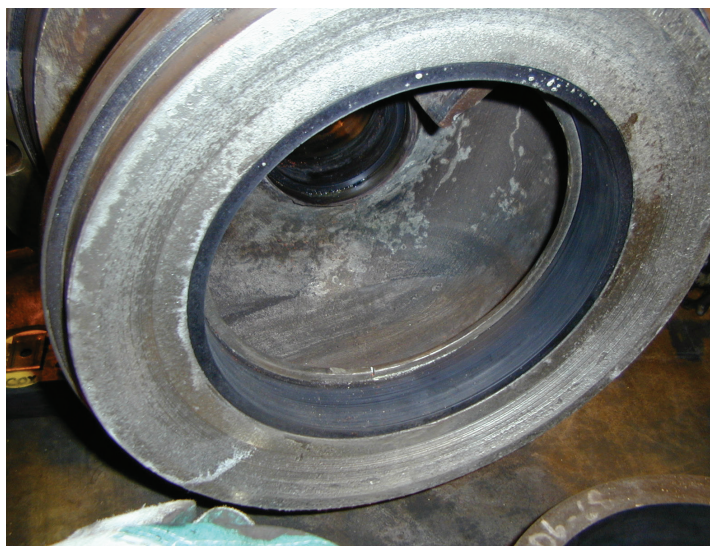
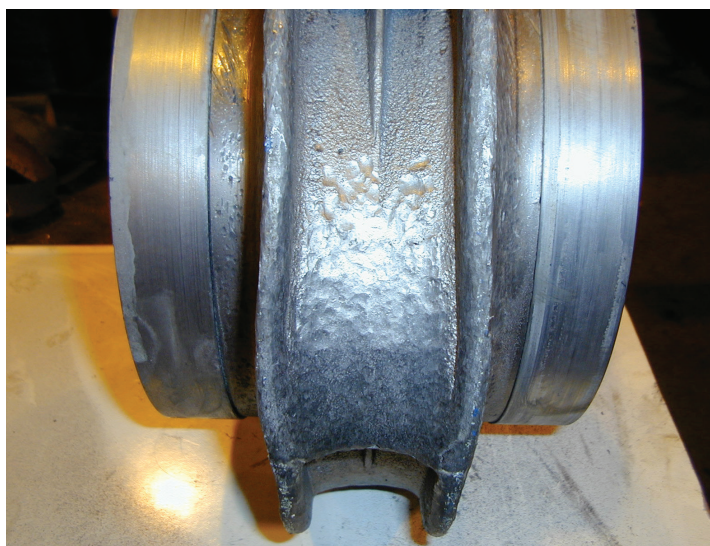
For example, in the photos a piece of metal is lodged in the impeller of the pump, causing extreme vibration. Operators immediately shut down the pump and switched to the installed spare. Fortunately, the pump had been rebuilt with composite case rings, which did not seize. The rotor spun down, the seals did not leak, and the plant continued to operate at

full capacity. Even after being exposed to such extreme loads, the composite rings were intact with minimal wear.
